METALS HANDBOOK

VOL. 9
FRACTOGRAPHY AND ATLAS OF FRACTOGRAPHY

8th EDITION

Fractography and Atlas of Fractographs

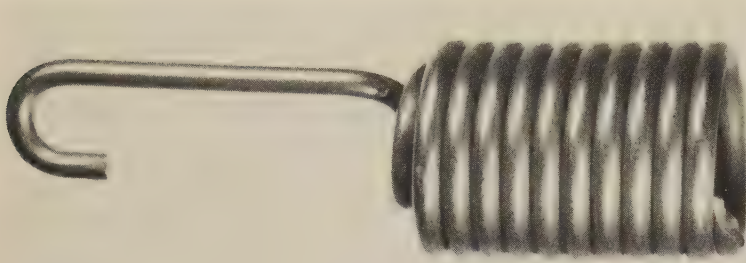
Photograph

3875 An aircraft throttle-control spring that broke in fatigue after 274 hr of service. The material was 17-7 PH stainless steel wire, 0.104-in. diam, heat treated to condition CH-900 and a hardness of Rockwell C 51 to 52. Expected tensile strength of the wire was 1889 to 2096 MPa (274 to 304 ksi). Fracture, visible at right, occurred at the third turn from the end of the spring; 3876 shows surface.

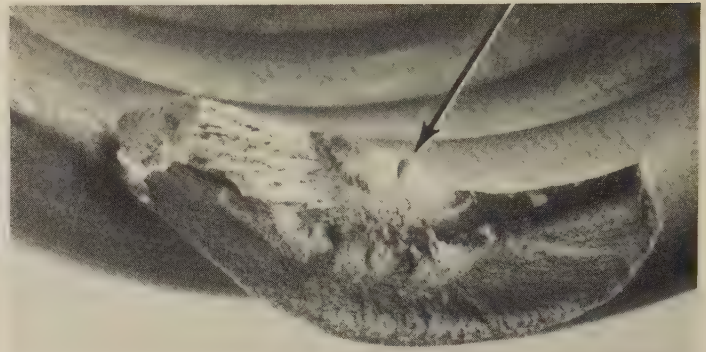
3876 Surface of the fracture in the coil spring shown in 3875 (at left). The crack nucleus is believed to be at the transverse "ledge" (indicated by the arrow) in the upper central portion of the clamshell pattern. See also 3877 to 3881 (below), and 3882 to 3884 (on facing page).

SEM fractograph 60×
3882 A larger view, by SEM, of the "ledge" (at arrow) in fractograph 3876 (facing page). The clamshell pattern of fatigue-crack arrests radiates from the crack nucleus. See fractograph 3883, at right.

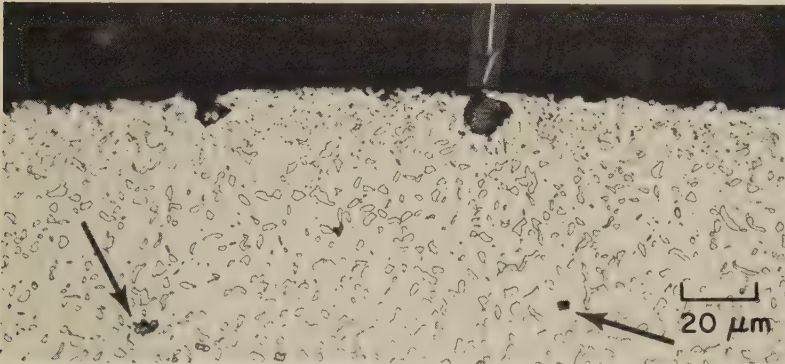
Micrograph (etchant: Marble's reagent)

3877 Microstructure of a cross section of the 17-7 PH stainless steel wire in 3875 and 3876, showing the distribution of inclusions (some are indicated by arrows), which in general was acceptable. (Note, however, the two large inclusions at the surface.)

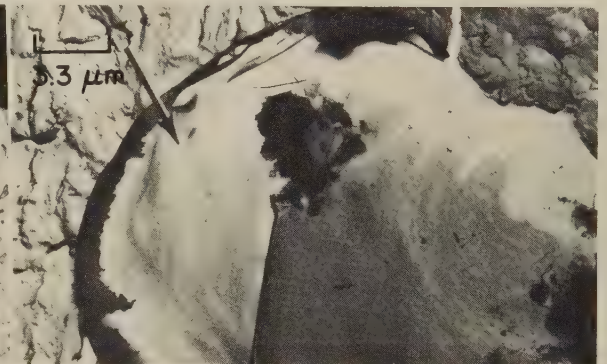
TEM fractograph

3878 A plastic-carbon replica of a large globular inclusion (arrow) similar to those visible in 3877. This inclusion was exposed by the fracture shown in 3876 and is located near the crack nucleus.

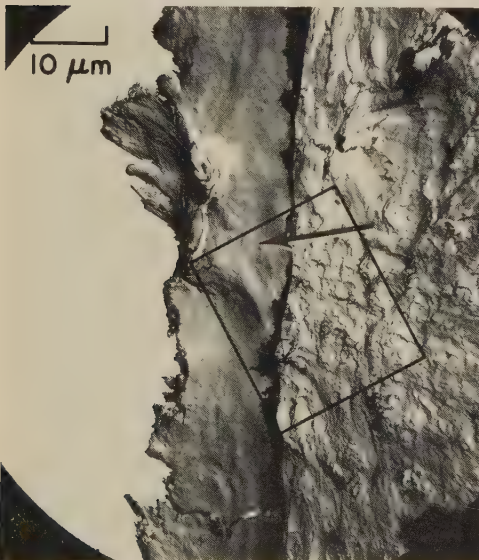
TEM fractograph (p-c replica)

3879 A very long inclusion (arrow) near the crack nucleus of the fracture in 3876 is shown here as a smooth dark surface. Fatigue striations lie parallel with the metal-inclusion interface. Area in rectangle is shown enlarged in 3880.

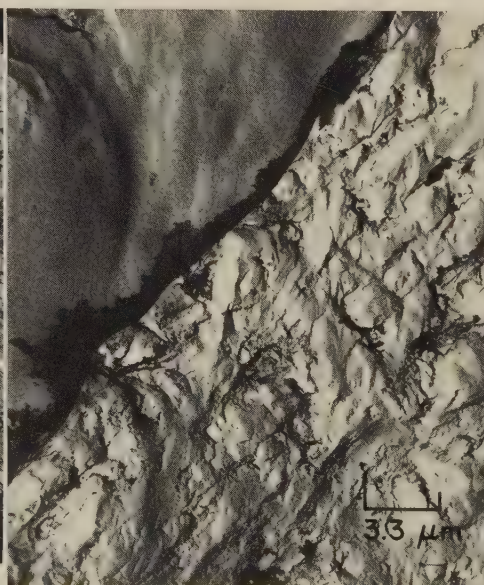
TEM fractograph (p-c replica)

3880 Area outlined by the rectangle in 3879, shown at higher magnification. Fatigue striations, which are not well defined, exist as irregular diagonal lines from upper right to lower left in this view.

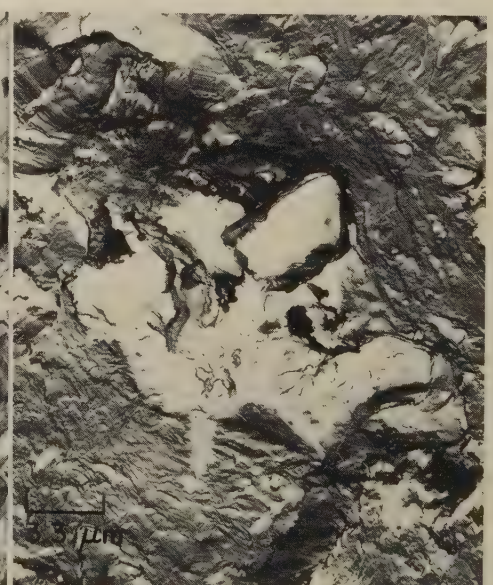
TEM fractograph (p-c replica)

3881 A view of an area of the fracture in 3876 that was not near the crack nucleus, showing high-stress, low-cycle fatigue striations and (at center) quasicleavage of what is presumed to be an inclusion.

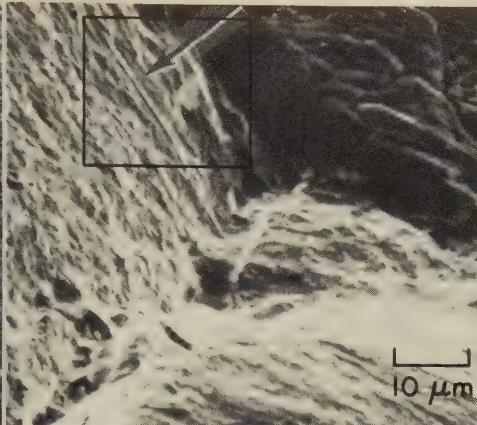
SEM fractograph 1000×
3883 Area outlined by the rectangle in 3882, shown at higher magnification. A slender inclusion stringer (at arrow) is visible in the face of the fracture surface. Rectangle here is shown enlarged in 3884.

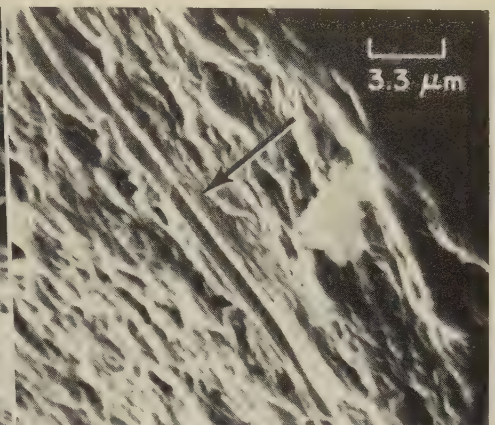
SEM fractograph 3000×
3884 Area in rectangle in 3883, shown at higher magnification. The inclusion stringer (indicated by the arrow) is still more clearly evident. This stringer may have been the crack-initiation site.

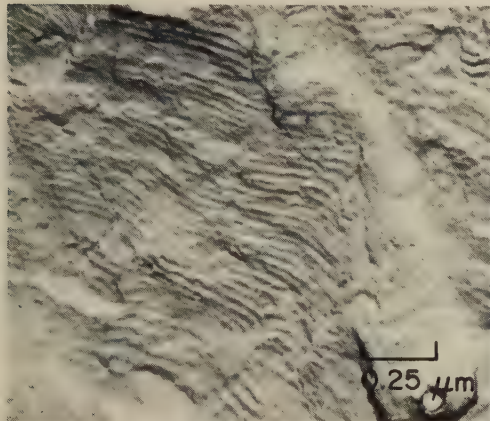
TEM fractograph (p-c replica) 40,000×
3885 Surface of a fatigue crack in type 301 stainless steel, produced at a stress-intensity range (ΔK) at the crack tip of 37.9 MPa·m^{1/2} (34.5 ksi·in.^{1/2}) at 95 C (203 F). Spacing of clearly defined fatigue striations is about 0.04 μm. See also 3886.

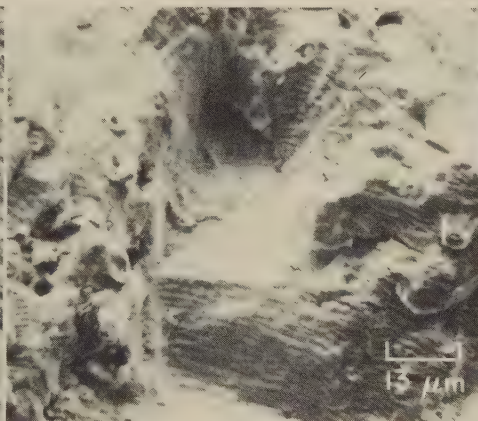
SEM fractograph 750×
3886 Surface of a fatigue fracture in type 301 stainless steel, produced at a stress-intensity range (ΔK) at the crack tip of 55 MPa·m^{1/2} (50 ksi·in.^{1/2}) at 95 C (203 F). Fatigue striations and secondary cracks are visible. See also 3885 and 3887.

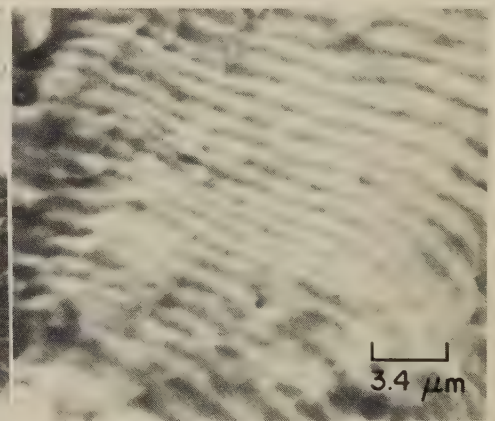
SEM fractograph 2950×
3887 A portion of the same fracture surface as that in 3886 but at higher magnification, showing occasional inclusion sites among the regular fatigue striations. Spacing of the striations is about 1.3 μm, which is much greater than that in 3885.

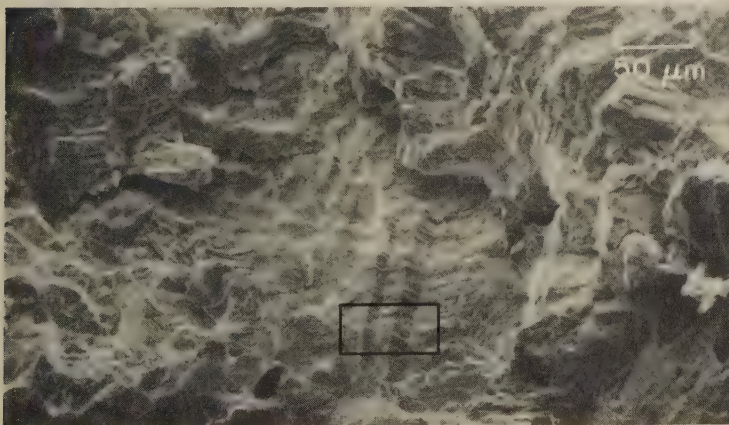
SEM fractograph 200×
3888 Surface of a fatigue-crack fracture in a specimen of type 301 stainless steel that was highly stressed, breaking in 2000 cycles. Crack growth was very irregular, with many pronounced offsets. At center, twin boundaries have affected crack propagation. Area in rectangle is shown at higher magnification in 3889.

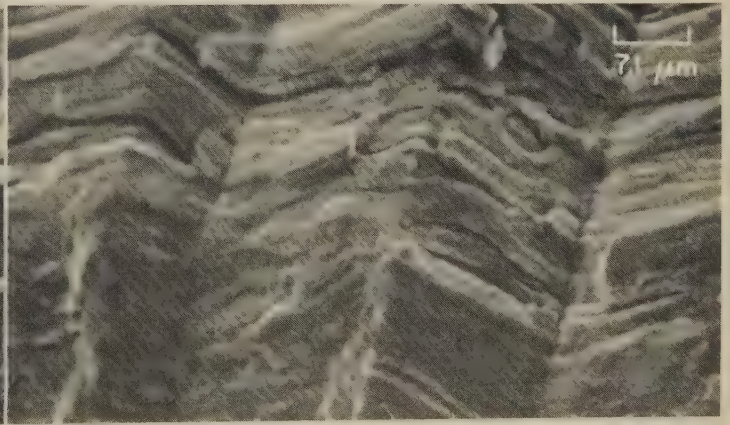
SEM fractograph 1400×
3889 A higher-magnification view of the area outlined by the rectangle in fractograph 3888, which includes twin-boundary outlines. Several secondary cracks have formed at the roots of the fatigue striations. The striae, however, are not delineated well enough to permit a confident estimate of the spacing.

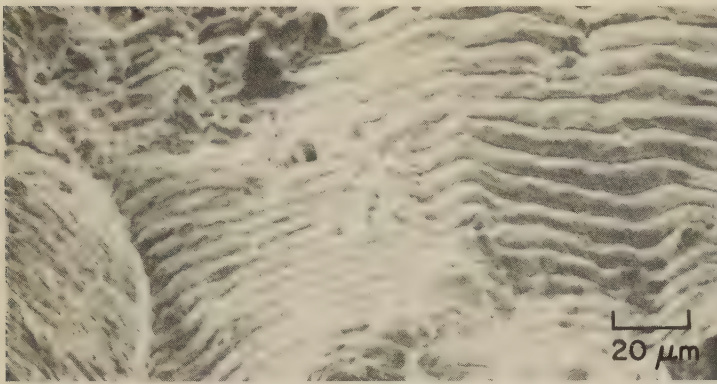
SEM fractograph

3890 Surface of a fracture in a specimen of type 304 stainless steel that was broken in a controlled-strain low-cycle fatigue test in air at 593 C (1100 F) at 12 cycles per minute. Before being tested, the specimen was solution annealed and then aged for 1000 hr at 593 C (1100 F). Maximum strain was 0.5% tension and compression, producing a maximum saturated stress of about 228 MPa (about 33 ksi) tension and compression. Fracture occurred at 3604 cycles. The fracture surface shows transgranular facets with clearly defined ductile fatigue striations. See also 3891.

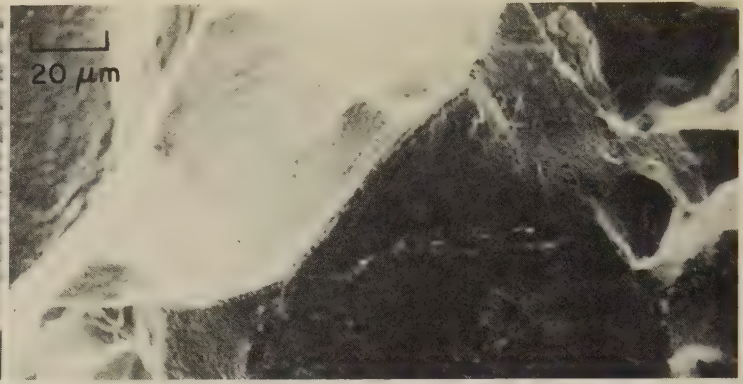
SEM fractograph

3891 Surface of a fracture obtained in low-cycle fatigue in air at 593 C (1100 F) in a specimen taken from the same heat of type 304 stainless steel as was the specimen in 3890 (at left), and subjected to the same heat treatment and test procedure, but held 10 min at the peak tensile strain of each cycle. Maximum strain was 0.5% tension and compression, which produced a maximum saturated stress of about 228 MPa (about 33 ksi) tension and compression. Fracture occurred at 636 cycles. The features of this fracture surface indicate that the fracture was intergranular.

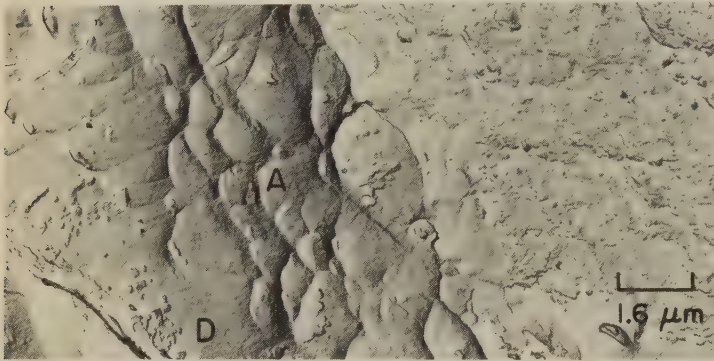
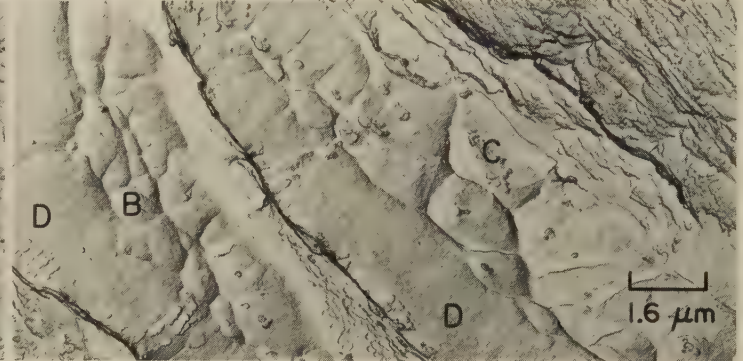
TEM fractograph (p-c replica)

3892, 3893 Two TEM views of a fracture obtained in a metastable austenitic stainless steel in a fracture-toughness test at -196 C (-321 F) after 80% deformation at 450 C (842 F). The alloy contained 0.20% C, 2.0% Mn, 1.0% Si, 13.5% Cr, 8.8% Ni and 3.0% Mo. The fracture surface was etched in a solution of 5 g CuCl₂ in 100 ml each of H₂O, HCl and CH₃OH, for identification of any martensitic regions. Visible are moderate-size tear dimples in the austenite (around A in 3892 and around B and C in 3893), fine bands of very small dimples in the martensite (upper right in 3893) and areas of stretched metal (at D's). See also 3894 to 3896.

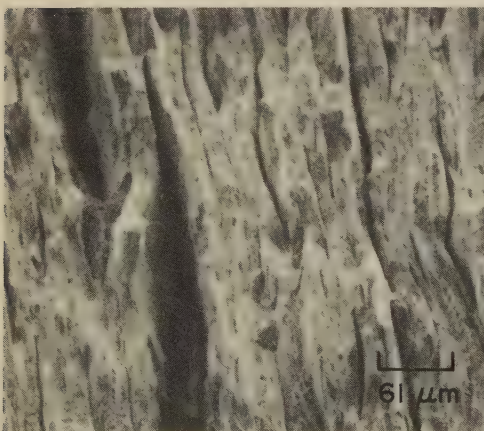
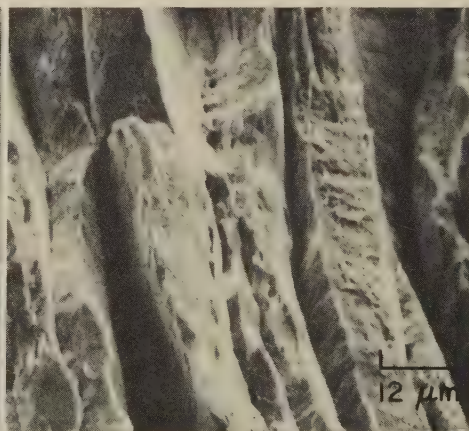
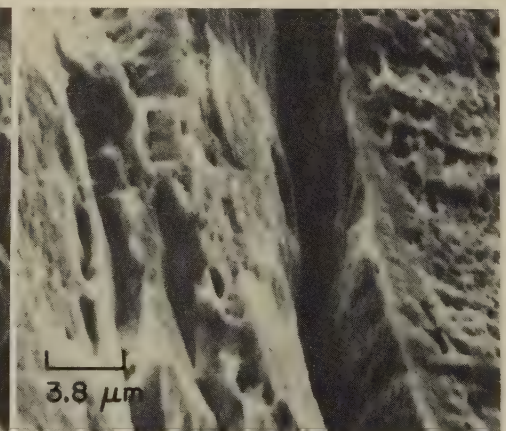
SEM fractograph

3894, 3895, 3896 Three SEM views of the surface of a fracture that was obtained at -196 C (-321 F) in a specimen of the same austenitic stainless steel as in 3892 and 3893, subjected to the same deformation prior to fracture-toughness testing. No etchant was used here. The rectangle in 3894 (left) indicates the area shown at higher magnification in 3895 (center), and the rectangle in 3895 indicates the area shown at still higher magnification in 3896 (right). The delamination visible in these three views is of the same nature and of the same order of magnitude as the bands of stretched metal shown in 3892 and 3893. The deep furrows are believed to be cracks in regions of martensite. Visible in 3896 are a fracture in martensite (right of center), a stretched region (to right of fracture) and dimples (at far right).

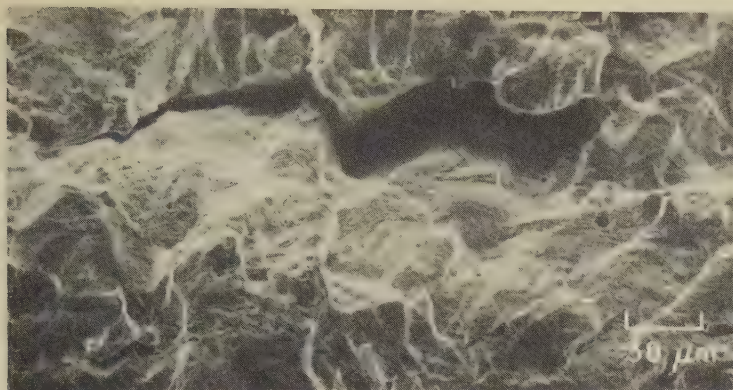
SEM fractograph

3897 Fatigue-precracked region of a specimen of an iron alloy containing 0.004% C, 0.01% Mn, 0.01% Si, 15.8% Cr and 12.5% Ni, fracture-toughness tested at a stress-intensity range (ΔK) of 35 MPa·m^{1/2} (32 ksi·in.^{1/2}) and at 90 C (194 F). Note pronounced secondary cracks, and that striation spacings just below the large crack are much narrower than elsewhere. See 3898.

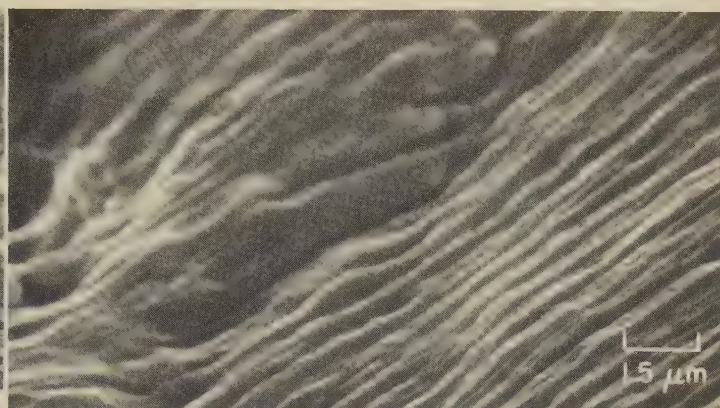
SEM fractograph

3898 Higher-magnification view of a region near the large secondary crack in the fatigue-fracture surface shown in fractograph 3897 (left). The fatigue striations appear to be remarkably smooth and continuous. At top and at left are suggestions of secondary cracks at the roots of striations.

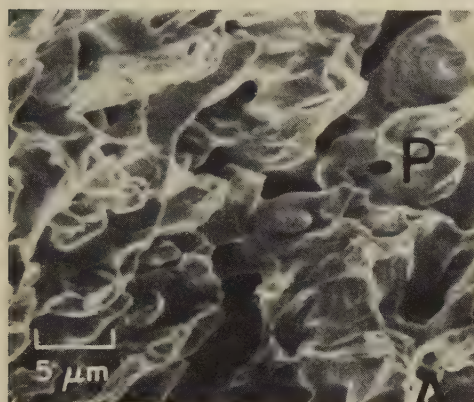
SEM fractograph

3899 Tensile-overload fracture in a compacted powder metallurgy specimen of type 316L austenitic stainless steel. Note that there are pores that were not closed in pressing. See 3900 for an enlargement of a region near letter P.

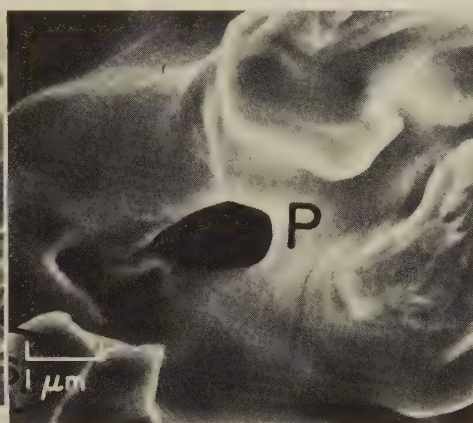
SEM fractograph

3900 Enlargement of a region near letter P in 3899 (letter P marks a pore that is visible in both views). The flow around the pores appears to be different from that away from them.

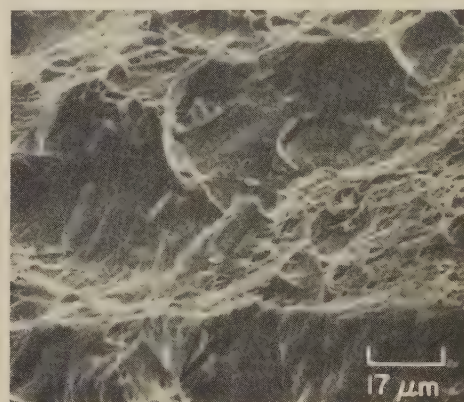
SEM fractograph

3901 Surface of an overload fracture in A-286 austenitic steel, showing a wide variation in size of tear dimples. Fatigue precracks in specimens of this alloy did not propagate during fracture-toughness testing in bending.

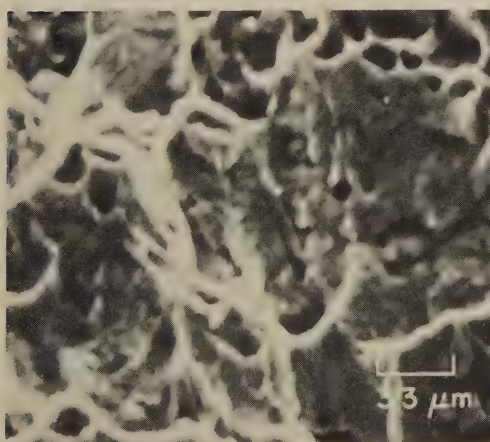
SEM fractograph

3902 Fracture surface of a specimen of Hastelloy X that was homogenized at 1149 C (2100 F) for 2 hr, water quenched, and then broken in a tensile test at 593 C (1100 F). Reduction in area, 45%. Note the tear dimples in this transgranular fracture. See also 3903 and 3904.

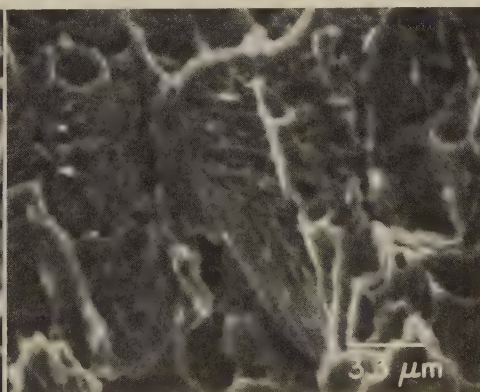
SEM fractograph

3903 Fracture surface in same alloy, and given same heat treatment, as in 3902. Although this specimen was broken in tension at 649 C (1200 F), reduction in area (29%) was lower than in 3902. This reflects "midrange minimum ductility", which is present in many nickel-base alloys. Tear dimples are present, but are accompanied by flat grain-boundary facets. See also 3904.

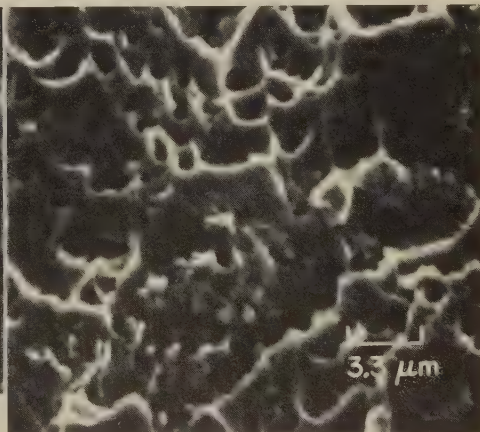
SEM fractograph

3904 Surface of a fracture in another specimen of Hastelloy X, given the same heat treatment as described in 3902, and broken in a tensile test at 760 C (1400 F). Reduction in area, 46%. This fracture is transgranular, and shows pronounced tear dimples. Compare with 3903 (left).

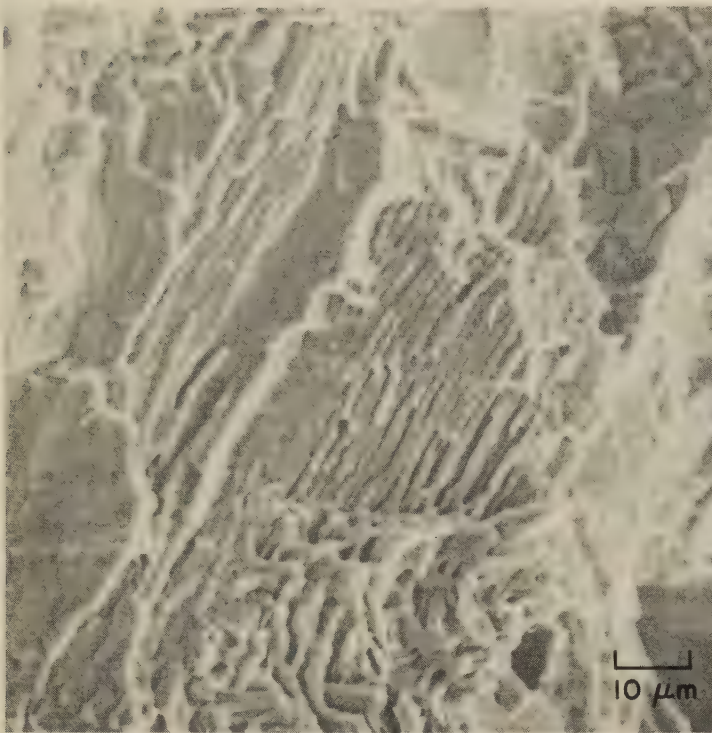
SEM fractograph

3905 An impact fracture at 22 C (72 F) in Refractaloy 26 alloy after solution annealing for 2 hr at 982 C (1800 F) and water quenching, followed by aging for 200 hr at 899 C (1650 F) and air cooling. The hardness was 205 dph. The fracture appears to have occurred by cleavage, with needle-like features reflecting the shape of Ni_3Ti precipitates. See also fractograph 3906, at right.

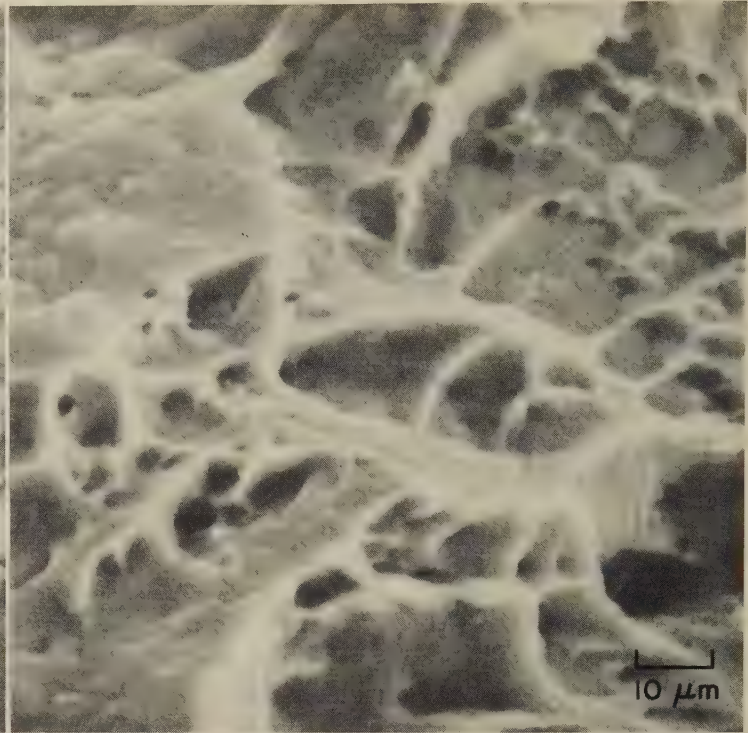
SEM fractograph

3906 An impact fracture at 22 C (72 F) in a specimen of Refractaloy 26 that was solution annealed same as specimen in 3905 but was then aged for 9 hr at 732 C (1350 F) and air cooled. The hardness was 410 dph. The fracture surface contains shear dimples with perhaps traces of stretched metal—in marked contrast with the fracture surface shown in 3905.

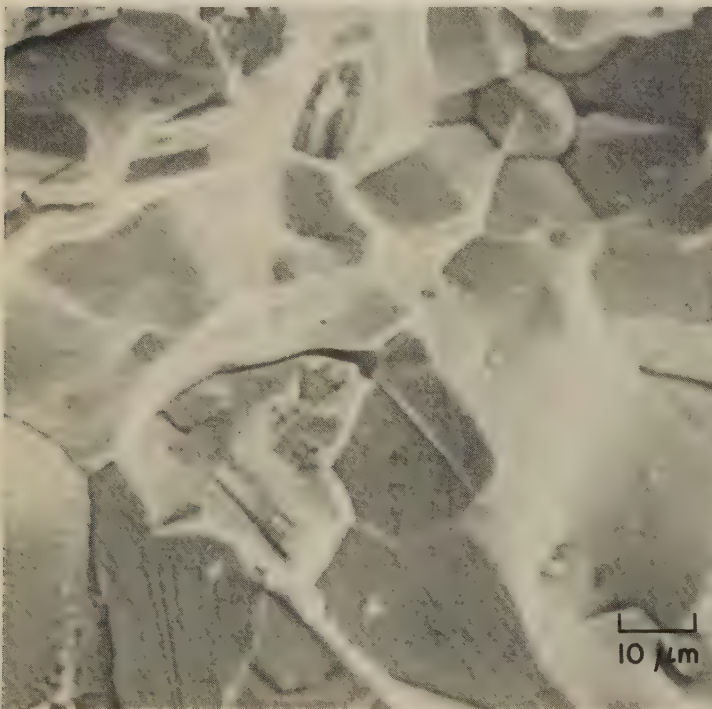
SEM fractograph

3907 A stress-rupture fracture in Refractaloy 26 alloy that had been solution treated for 2 hr at 982 C (1800 F), water quenched, then aged 9 hr at 732 C (1350 F) and air cooled. Specimen was loaded at a stress of 785 MPa (114 ksi); rupture occurred after 33 hr at 566 C (1050 F). A typical intergranular "rock candy" fracture, with slip bands in the grain facets. See also 3908.

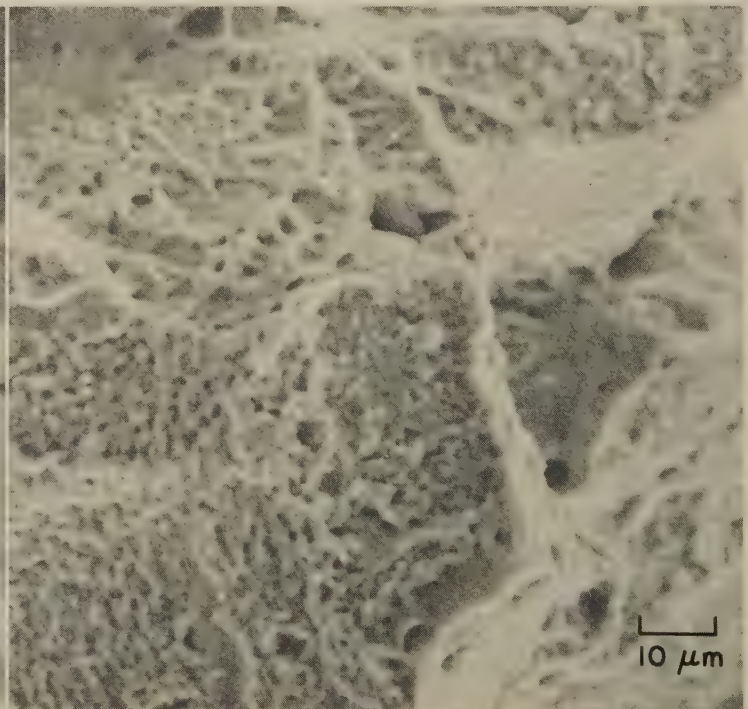
SEM fractograph

3908 A stress-rupture fracture in a specimen of Refractaloy 26 alloy that had been given the same heat treatment as the specimen in 3907, but for which rupture occurred after 3713 hr at 700 C (1292 F) under a load of 275 MPa (40 ksi). Hardness of both specimens was 430 dph. The higher test temperature here resulted in formation of a myriad of dimples on intergranular surfaces.

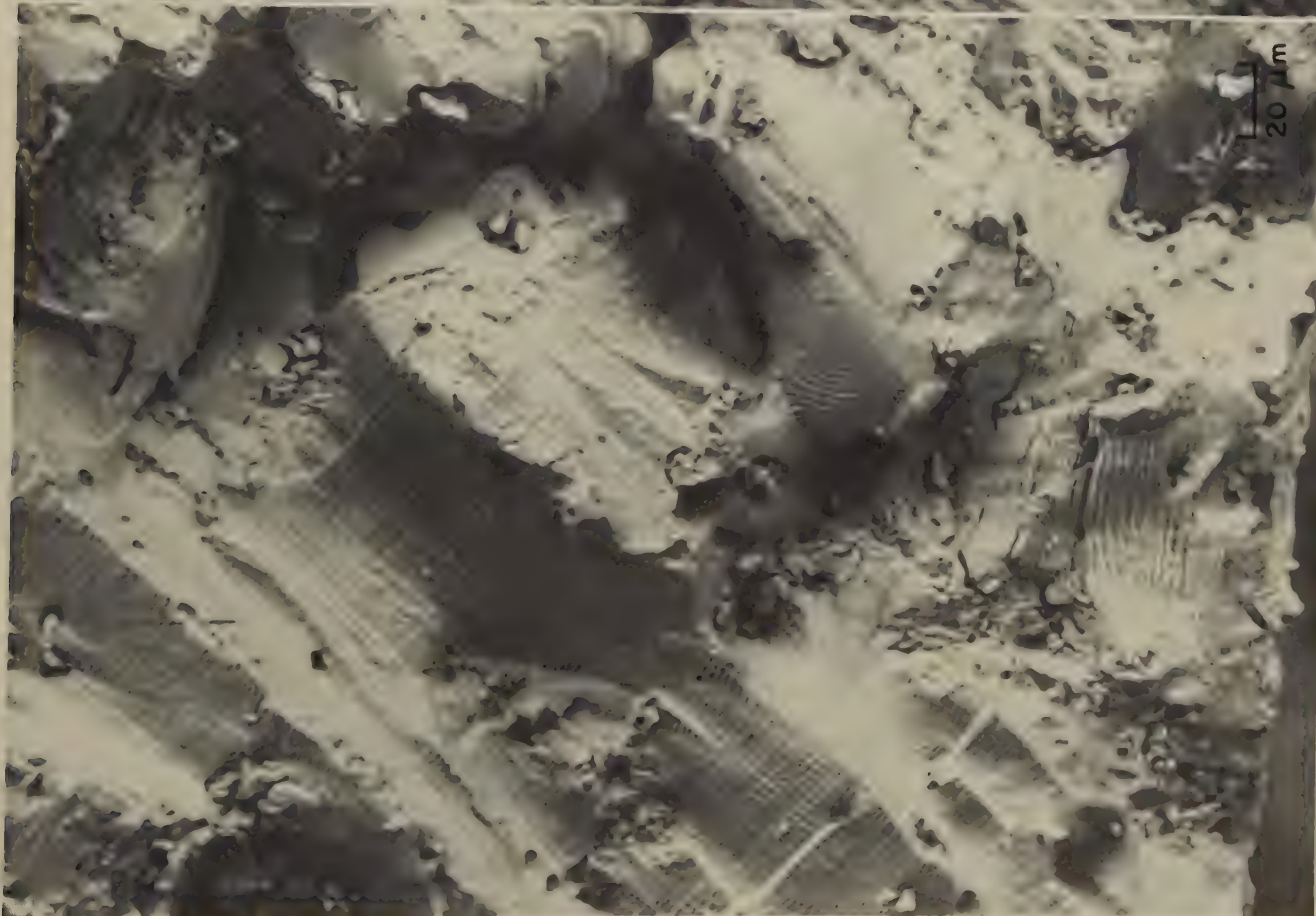
SEM fractograph

3909 Surface of a fracture in a specimen that was cast from alloy 718, produced in a fatigue test at room temperature. The fatigue striations are clearly visible, defining a number of adjacent fatigue patches in which the cracks advanced on separate fronts. At upper right is a region of shrinkage porosity, encompassed by rounded dendrite arms. See also fractograph 3910.

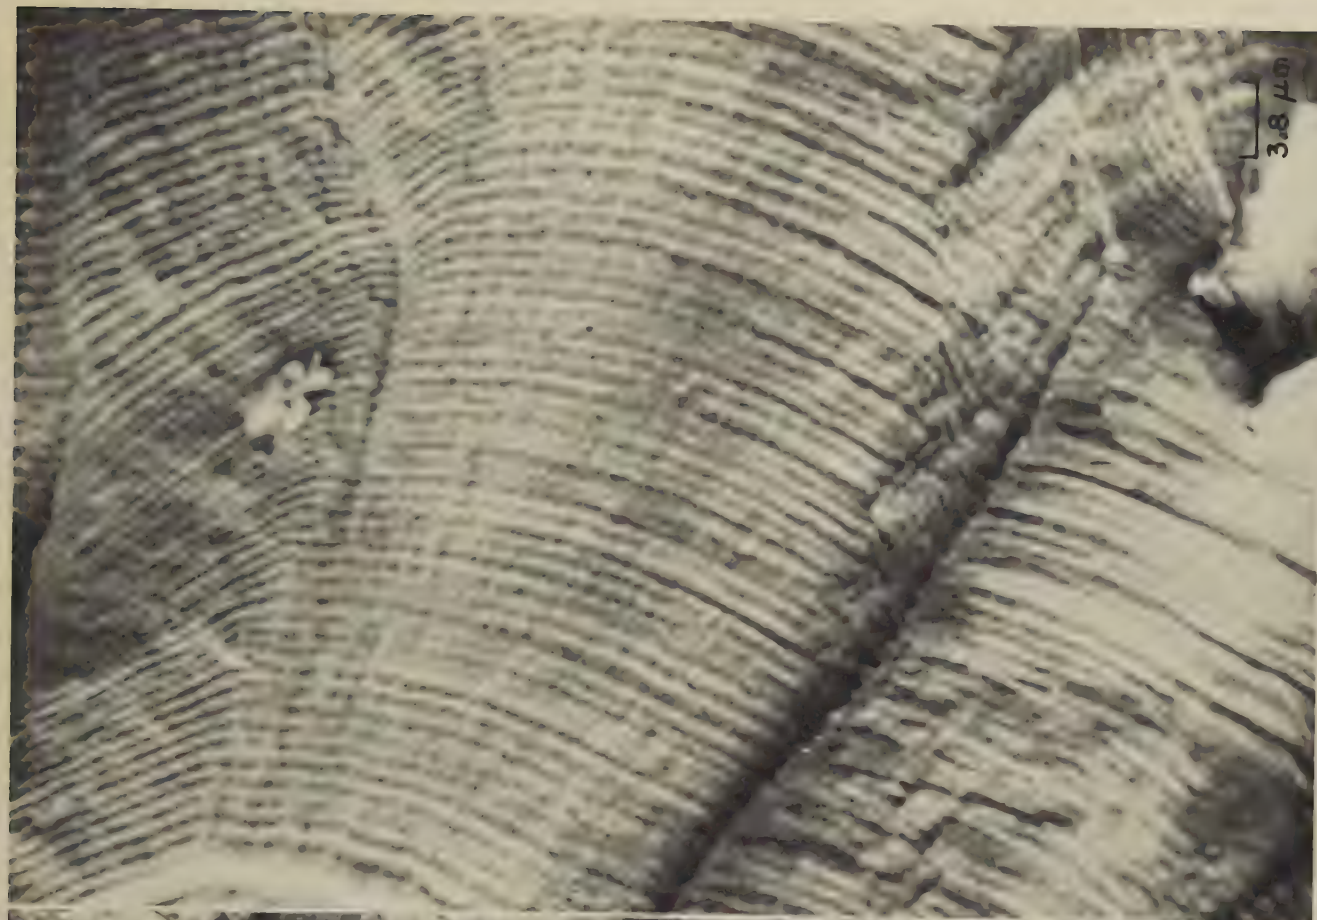
SEM fractograph

3910 A higher-magnification view of the same fracture surface as that shown in 3909, although not from exactly the same area. Here, the direction of fatigue-crack propagation was roughly left to right. The steps separating the fatigue patches are clearly visible, particularly at lower left. The spacing of fatigue striations in the central patch is approximately 1 μm.

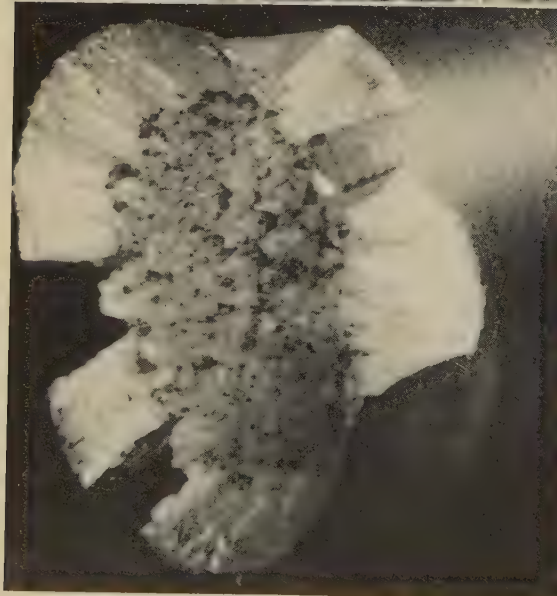
3911 A cup-and-cone fracture produced by overload tension at room temperature in an unnotched specimen of alloy 718 having a tensile strength of 1444.5 MPa (209.5 ksi) and 36% reduction in area. The central, origin zone is extremely rough. The shear lip has a small amount of cracking. See also fractographs 3912 and 3913, at right.

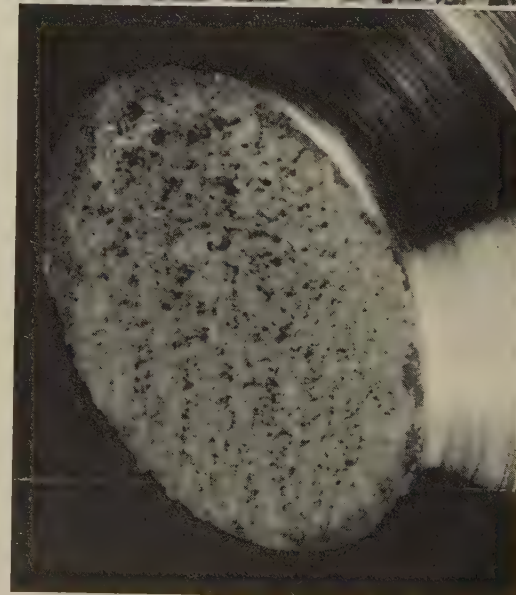
3914 A flat fracture produced by overload tension at room temperature in a notched specimen of alloy 718 having a notched tensile strength of 2048 MPa (297 ksi), and the same mechanical properties before notching as the specimen in 3911. The fracture surface is coarse. See 3915, 3916.

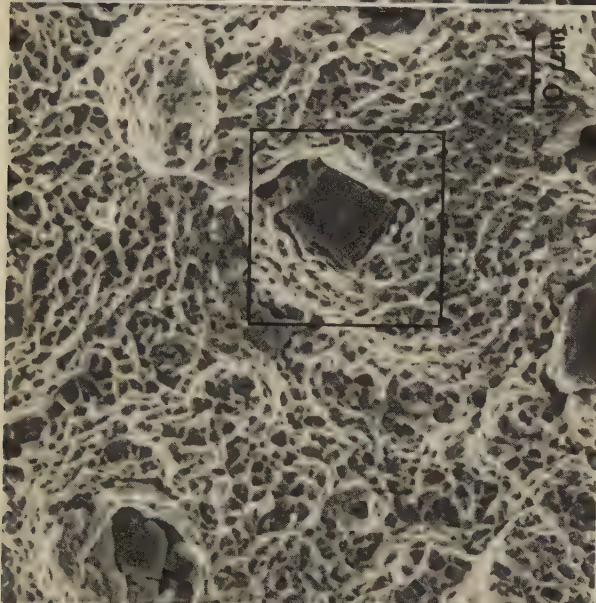
3912 An SEM view of an area in the central zone of the fracture in 3911. This area is composed of equiaxed dimples and a rather uniformly distributed precipitated phase, which is bonded to the matrix generally but is separated from it locally by cracks. See 3913.

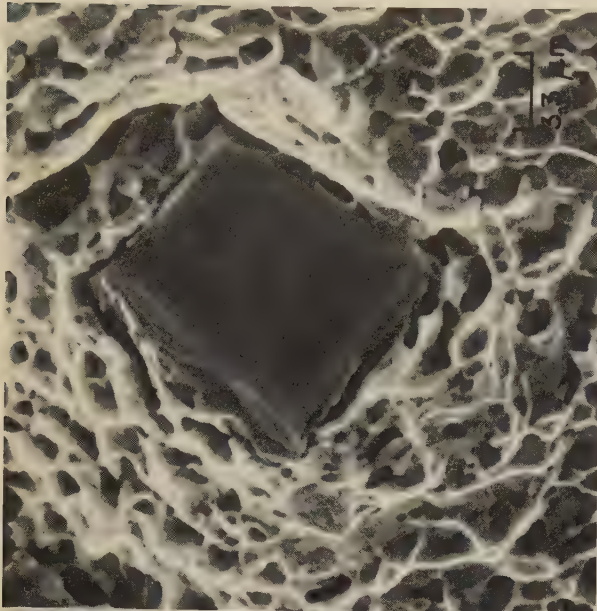
3913 Area outlined by the rectangle in 3912, shown at higher magnification. It is evident that, despite the appreciable amount of deformation produced by the tensile test, the particle in the center is still almost completely adherent to the matrix.

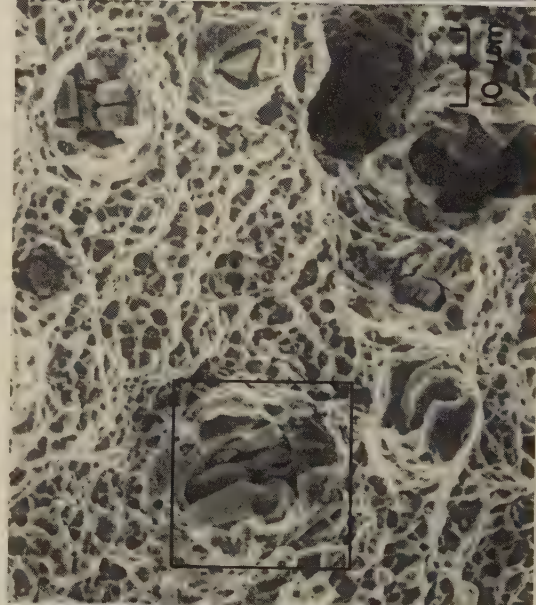
3915 SEM view of the fracture surface in 3914, showing equiaxed dimples in the matrix areas. The precipitated phase, unlike the behavior of this phase in the unnotched specimen in 3911-3913, has fractured into many pieces in nearly every location. See 3916.

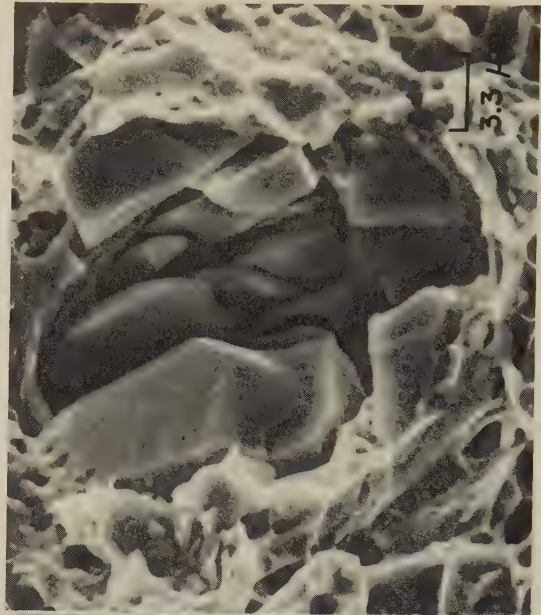
3916 Higher-magnification view of area in rectangle in 3915, showing a large particle of precipitated phase. The complex cracking of the particle is clearly evident. Note, however, that the matrix has not flowed away from the pieces but still adheres to them.

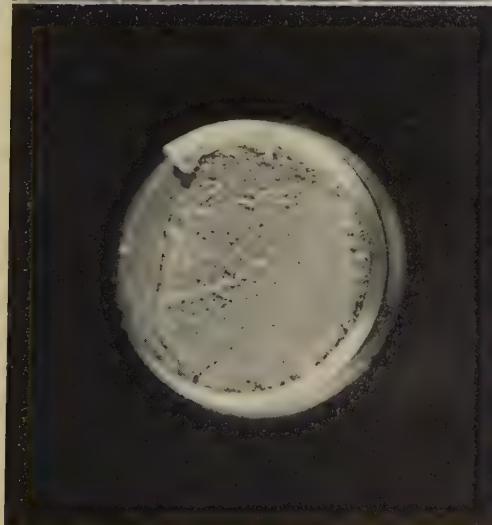
3917 Fracture produced at 33,000 cycles of low-cycle fatigue in a threaded specimen of alloy 718 in tension-tension ($R = 0.1$) at room temperature, maximum load at 862 MPa (125 ksi) — about 60% of the tensile strength. Origin was in the large, smooth crescent in the lower area. See also fractographs 3918 and 3919.

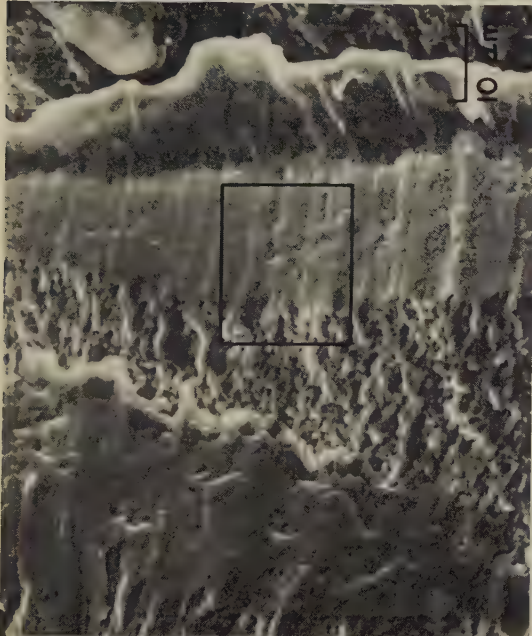
3918 Outer extremity of the fracture in 3917. The striations falsely resemble fatigue striations; actually, they are one order of magnitude larger than true fatigue striations and are considered to be slip steps. See 3919 for a larger view of area in rectangle.

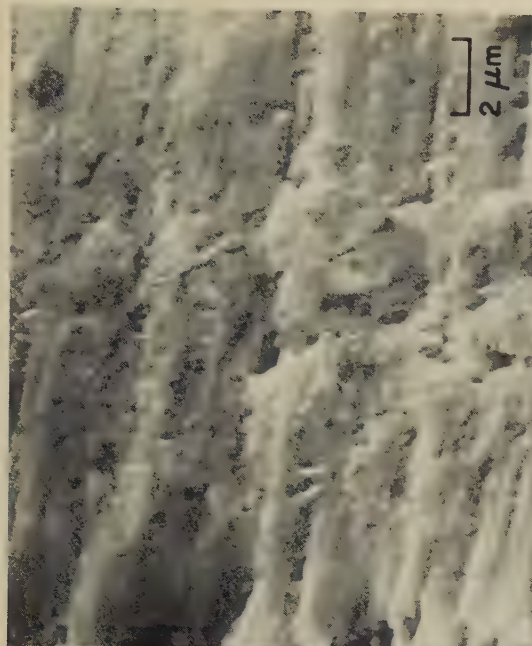
3919 Area in rectangle in 3918, at higher magnification. There are no signs here of the true fatigue striations that are seen in the TEM replicas from this fracture shown in fractographs 4501, 4503 and 4504; however, those TEM replicas are not from this same location.

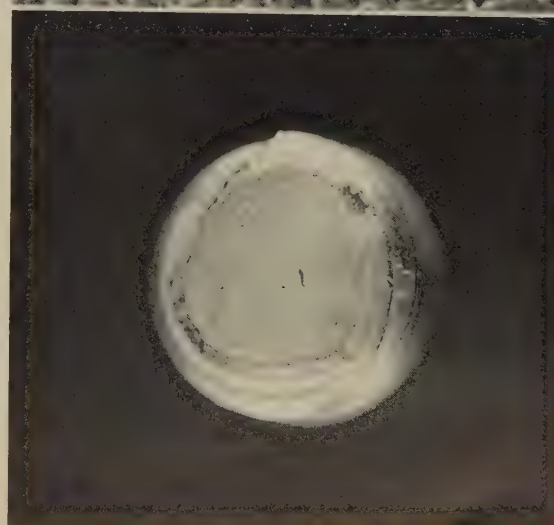
3920 A high-cycle fatigue fracture in a threaded specimen of alloy 718 in tension-tension ($R = 0.1$) at room temperature, maximum load at 434 MPa (63 ksi) — or about 30% of the tensile strength. Rupture was at 1648 kc. Surface is quite smooth. See 3921, 3922.

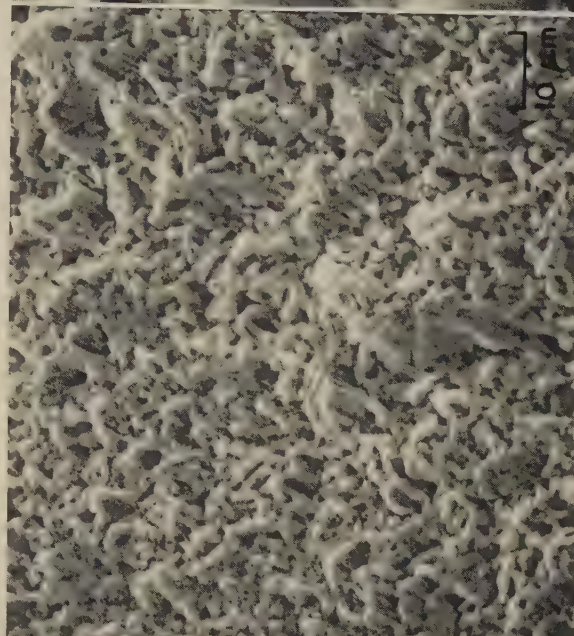
3921 This area of the fracture surface in 3920 is of interest in that it is nonorthodox: there are no striations, no dimples and no cleavage facets; instead, small ligaments formed (perhaps by slip) and then snapped off. See also fractograph 3922, at right.

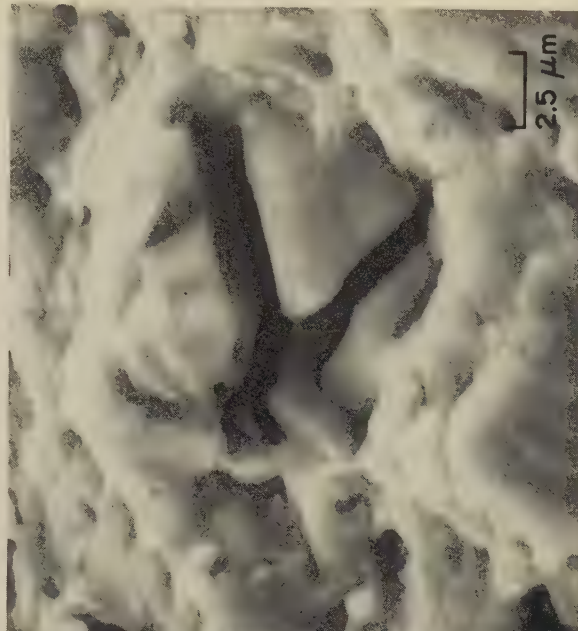
3922 View of another area of the fracture surface in 3920. The features in the lower foreground are possibly fatigue striations, but are too poorly resolved for accurate determination. At center is an inclusion that fractured during rupture of the specimen.

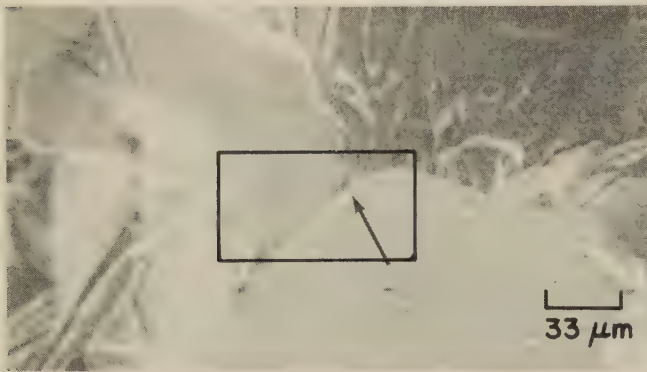
SEM fractograph

300×

3923 Fatigue-fracture surface of a specimen of U-700 alloy tested at 600 cycles per minute at 760 C (1400 F) under a stress cycling between 34 and 621 MPa (5 and 90 ksi), with fracture at 1800 kc. Arrow designates the subsurface origin of the fatigue crack. See 3924 (enlargement of area in rectangle), and 3925 to 3928.

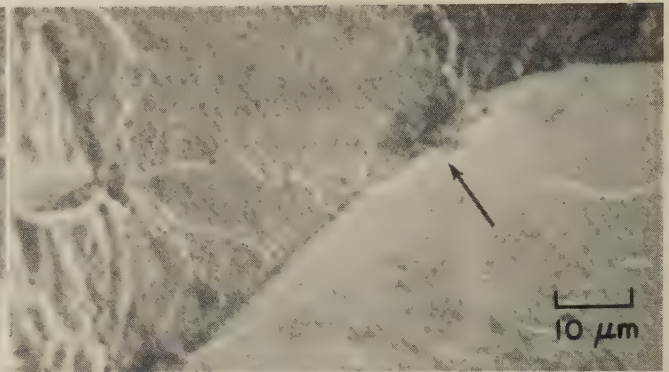
SEM fractograph

1000×

3924 View at higher magnification of the area in the rectangle in 3923. Arrow designates the crack origin, which was at the interface between the matrix and a particle (missing here) at a grain boundary. Crack growth was along {111} planes in two grains, and transverse to the {111} planes in a third (upper right).

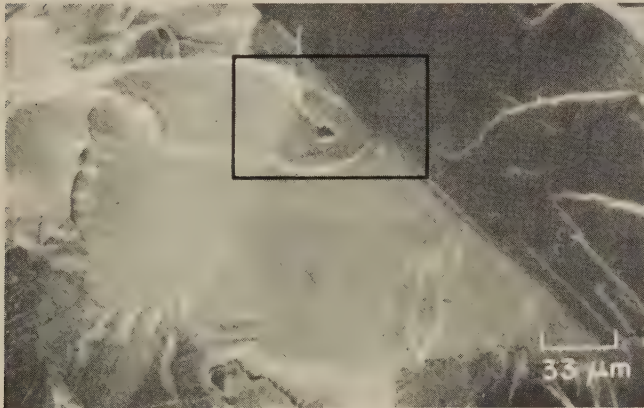
SEM fractograph

300×

3925 A fatigue fracture in U-700 alloy tested at the same frequency, temperature and stress as for 3923. Fracture was at 347 kc after 8 hr. Crack initiation was at the intersection of two coherent annealing-twin boundaries. Area in rectangle is shown enlarged in 3926.

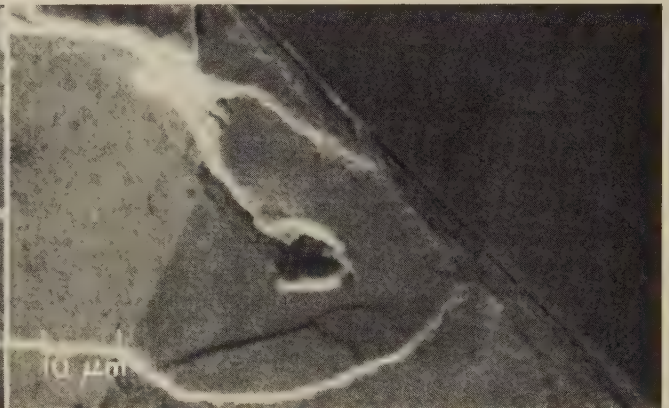
SEM fractograph

1000×

3926 Area within the rectangle in fractograph 3925, shown here at higher magnification. The particle near the center, which is thought to be TiC, is close to the crack origin. Crack propagation was along the {111} plane of the twins, and thereafter was transverse.

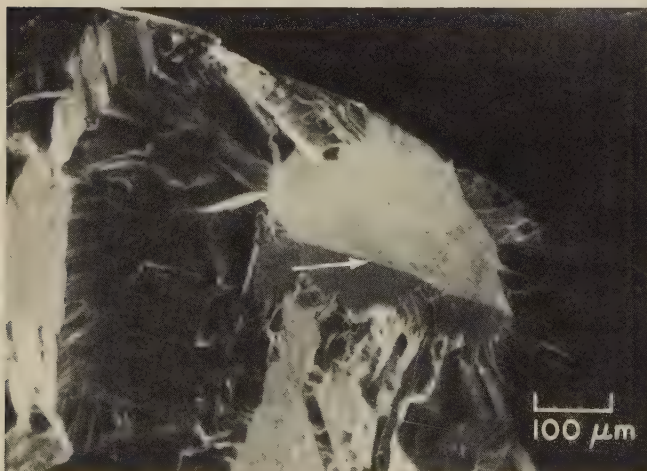
SEM fractograph

100×

3927 A fatigue fracture in U-700 alloy tested at the same temperature and stress as for 3923 and 3925, but at a frequency of 60,000 cycles per minute. Fracture occurred at 240 kc after 4 min. The crack, like that in the fracture shown in 3925, initiated at an intersection of coherent annealing-twin boundaries (arrow).

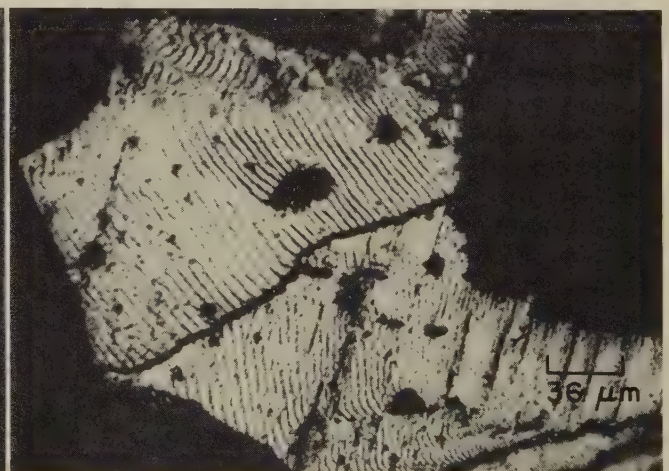
Light fractograph

280×

3928 A {111} facet oriented at an angle of 60° to 70° to the stress axis of a specimen of U-700 alloy fractured in a low-frequency (≤ 20 cycles per minute) fatigue test; other test conditions were same as for 3923. The facet, which lies in the perimeter of the fatigue zone, shows fatigue striations but no river patterns.

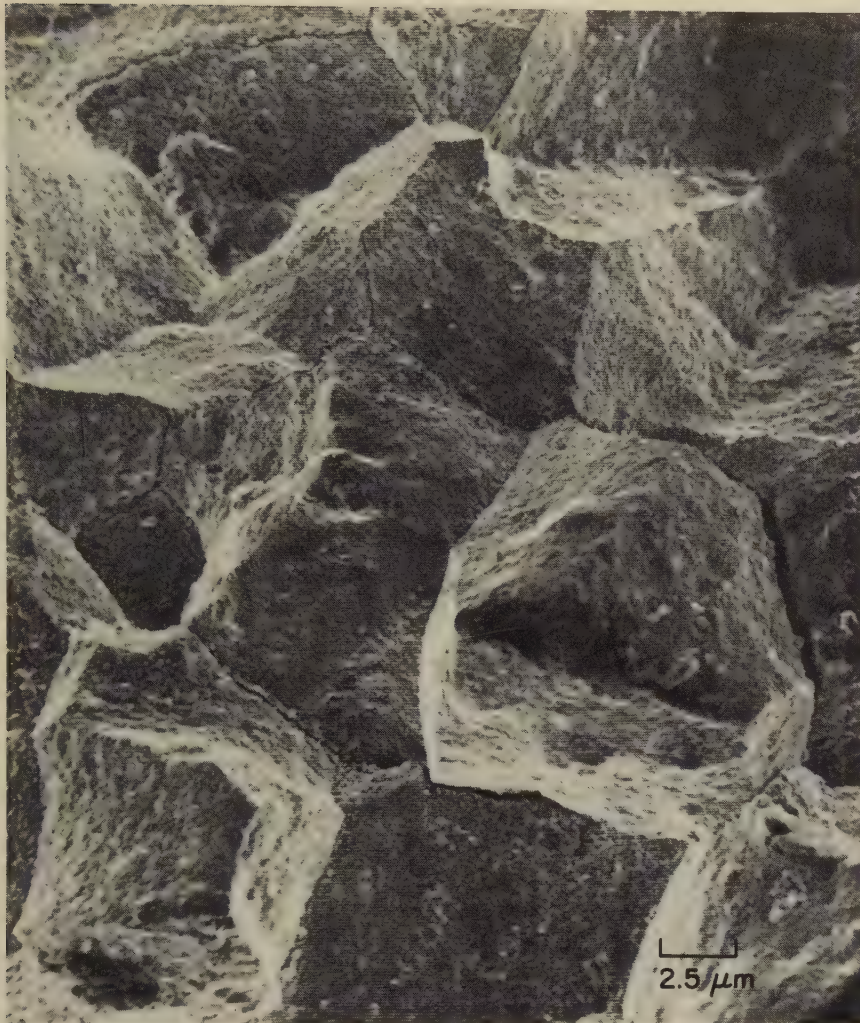
SEM fractograph

400×

3929 An outstanding example of an intergranular fracture surface. Specimen is wrought Waspaloy that was fractured in a stress-rupture test. Secondary cracks are visible in a number of grain boundaries. The grain facets appear to be coated with oxide; some may have a surface of fine dimples.
